**Smoky Canyon Mine  
Non-Time-Critical Removal Action (NTCRA) – 2015 Activities  
Pole Canyon Overburden Disposal Area**

**Weekly Construction Report**

Prepared by: Formation Environmental (on behalf of the J.R. Simplot Company)

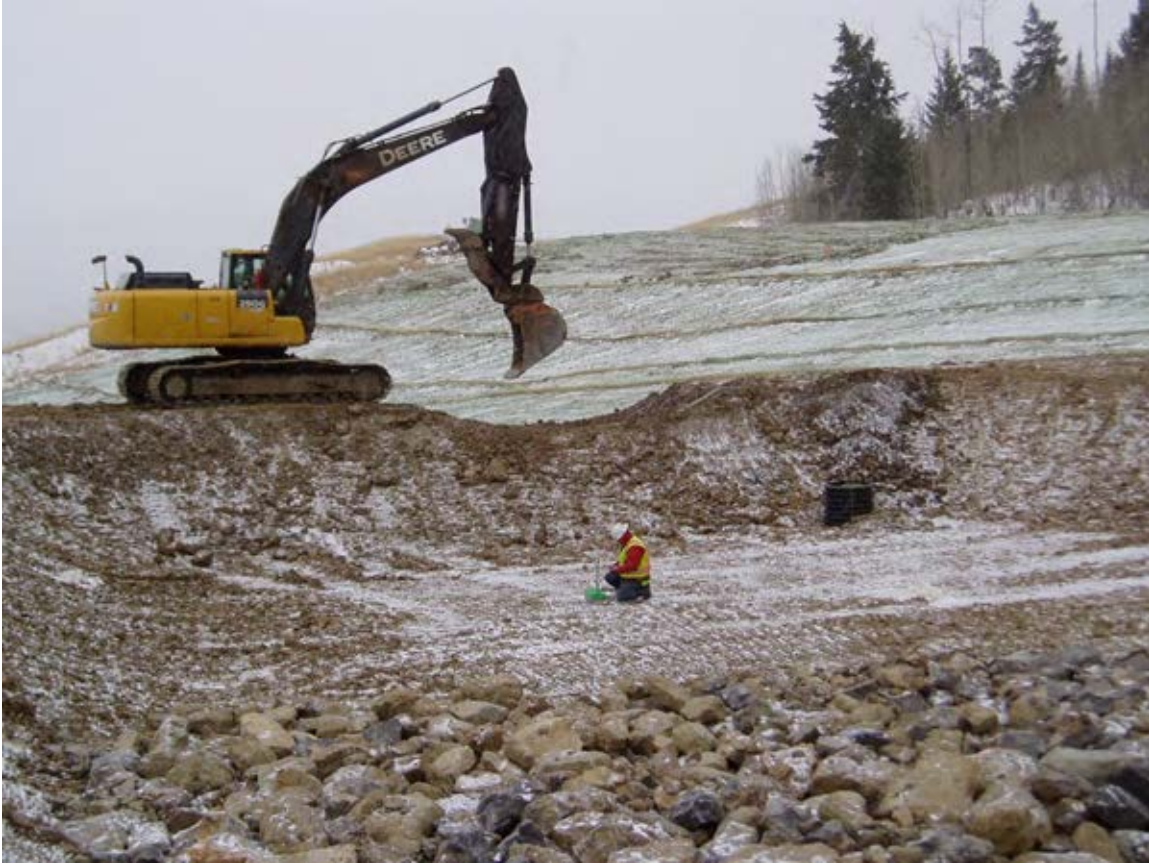
- CQC surveying with GPS unit to verify chert and Dinwoody cover thicknesses continued as necessary.
- CQC testing of compacted Dinwoody fill placed for the West-Side South Sedimentation Basin embankments (Photograph 11).

Photograph 11: Looking south across West-Side South Sedimentation Basin as QC field technician takes density reading with nuclear densometer to confirm compaction of the Dinwoody liner material. Low flow inlet riser pipe near corner of basin.

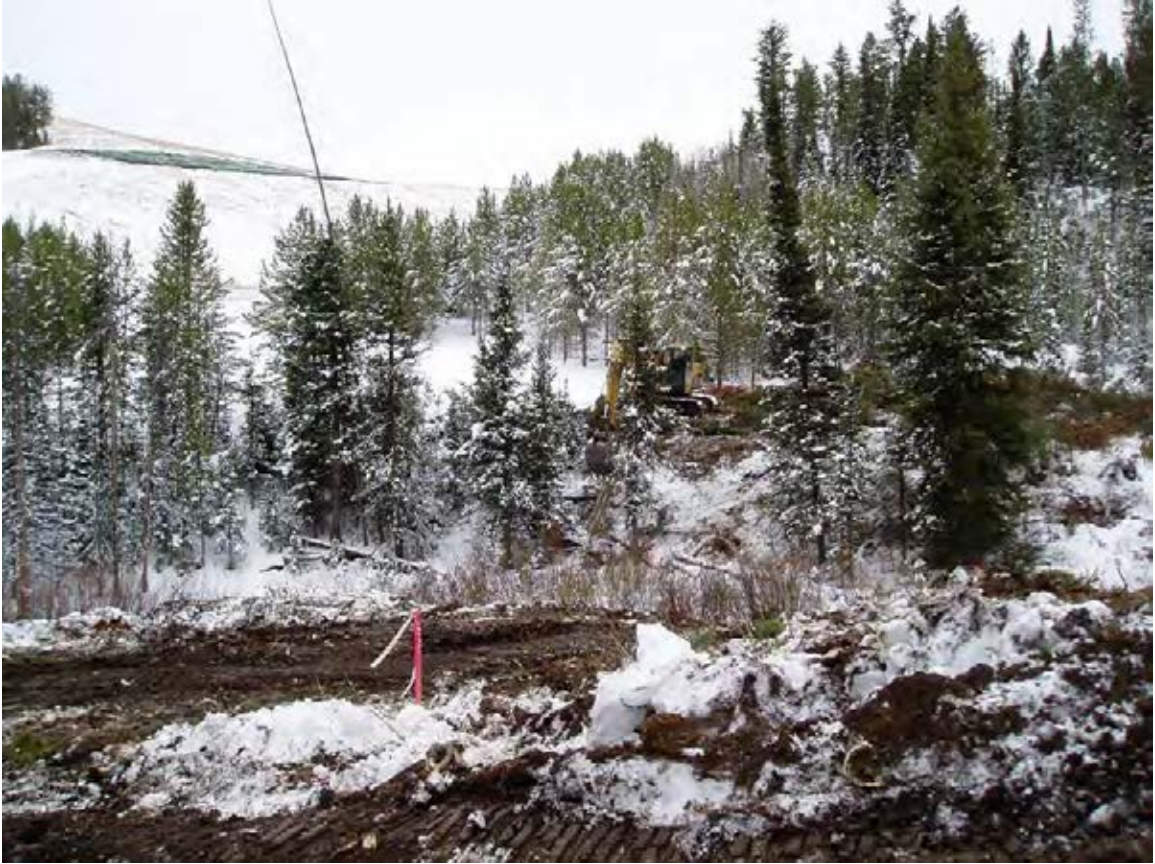
Photograph 1: Looking south towards West Sedimentation Basin as excavator initiates clear and grub for basin enlargement.

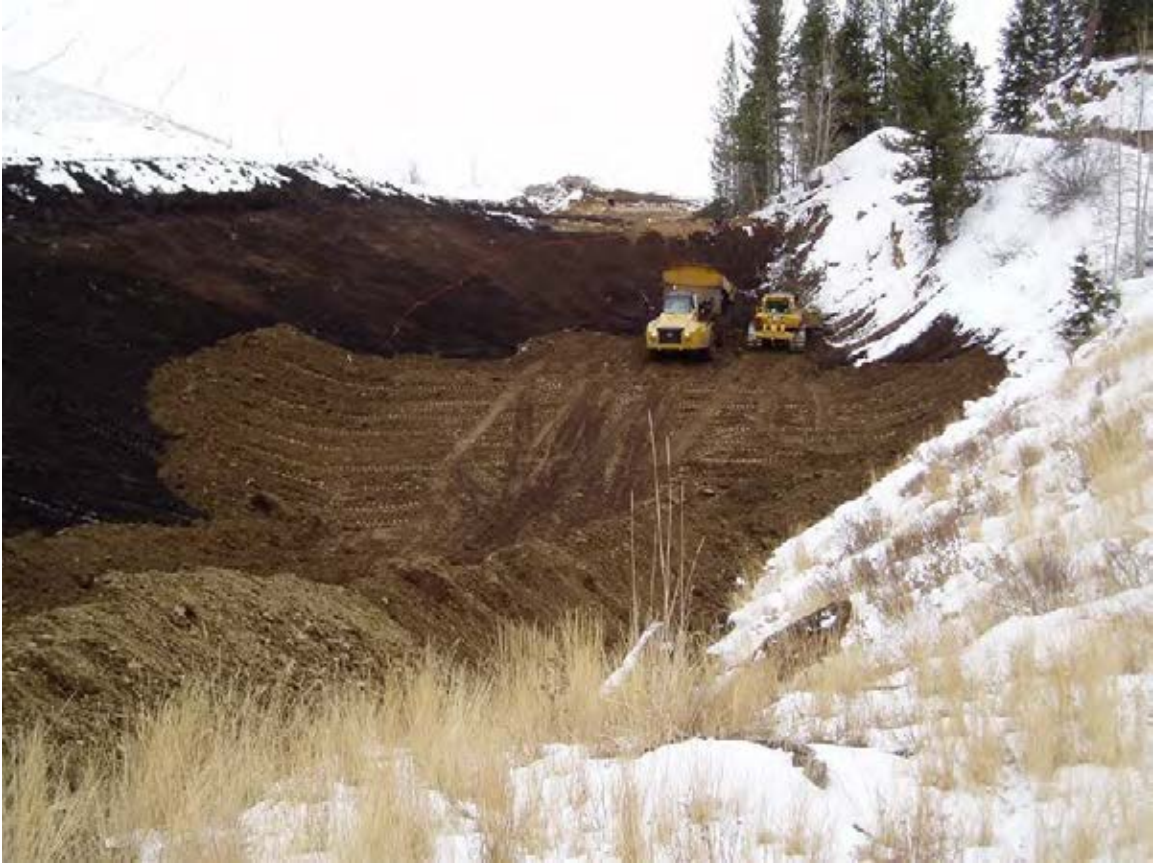
Photograph 2a: Looking south towards Northwest Sedimentation Basin as Dinwoody material is being hauled and placed in Cell 1 and 2 basins and side-slopes.

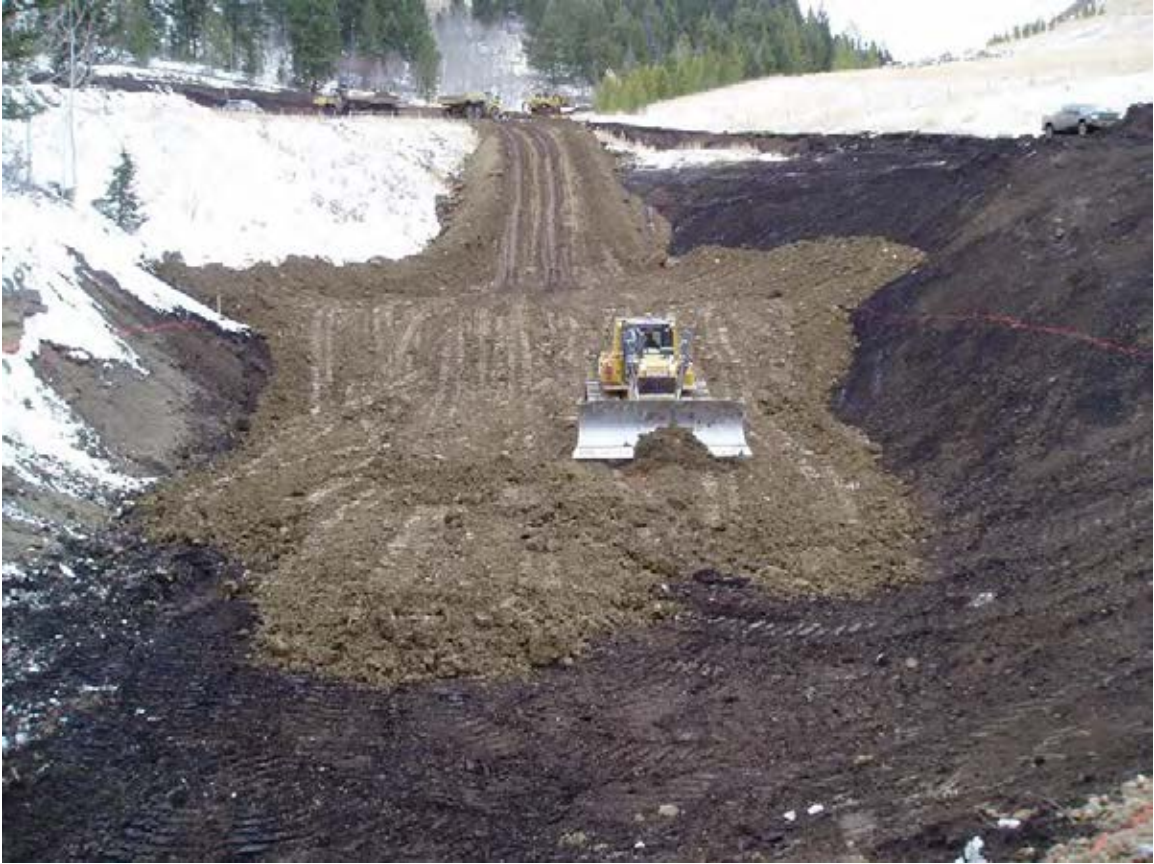
Photograph 2b: Looking north towards Northwest Sedimentation Basin as Dinwoody material is being hauled and placed in Cell 1 and 2 basins and side-slopes..

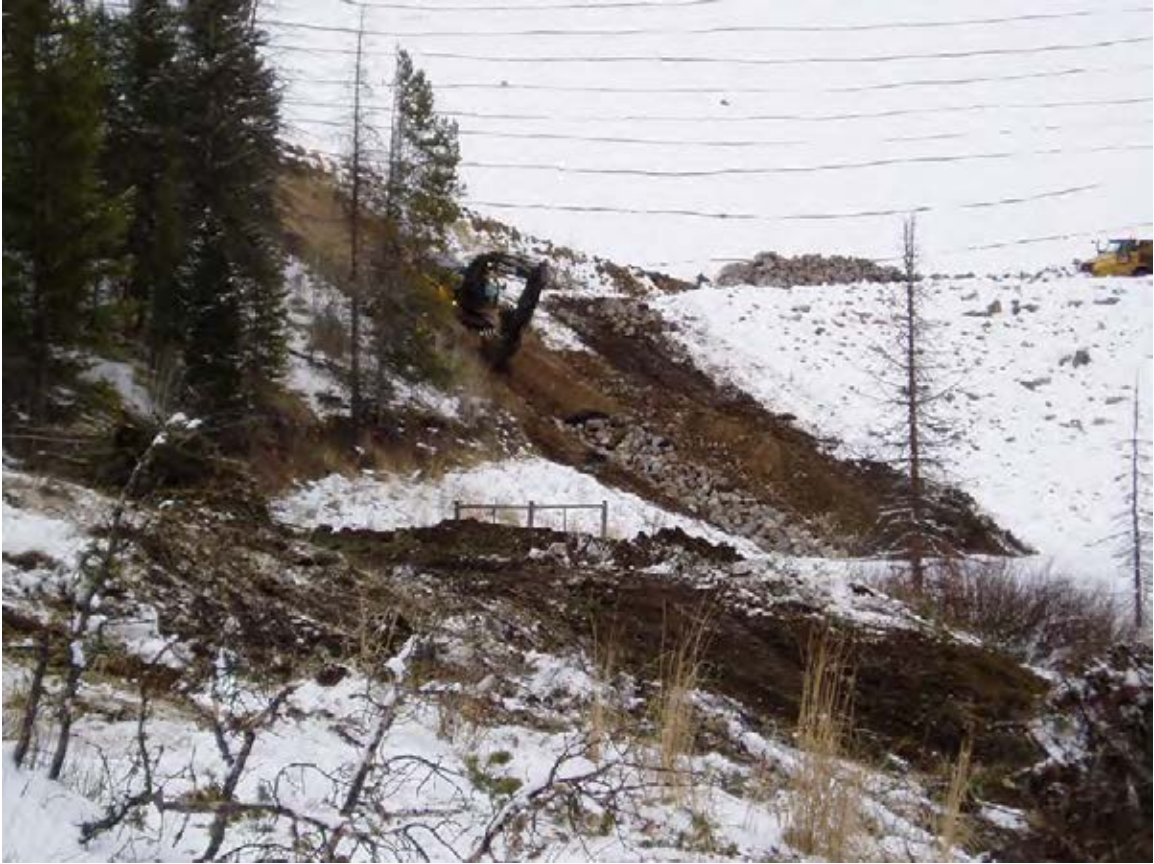
Photograph 3a: Looking east towards Northwest Sedimentation Basin outfall as riprap is being placed in outfall channel to infiltration basin.

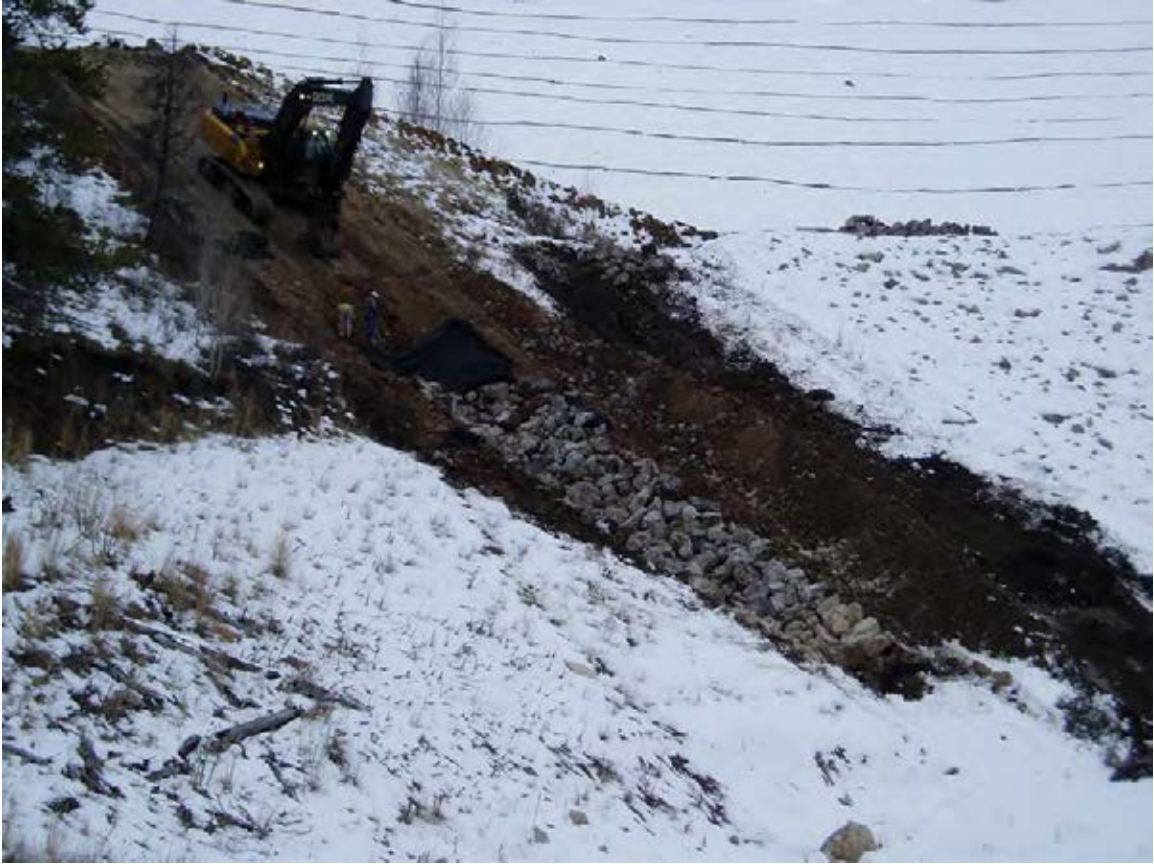
Photograph 3b: Looking east as workers place geofabric liner in Northwest Sedimentation Basin outfall chute prior to the placement of riprap.

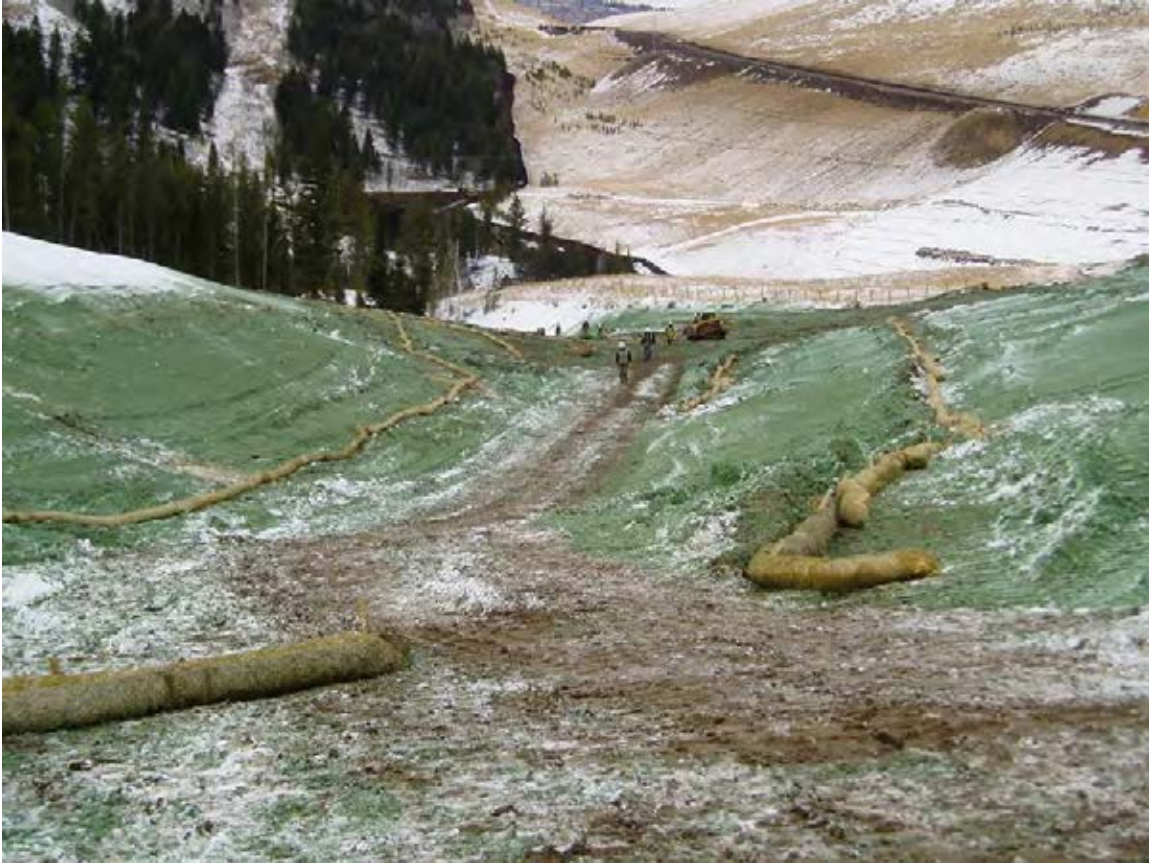
Photograph 4a: Looking north towards north end of Dinwoody borrow area as workers install erosion control straw wattels. Hydroseeding being done simultaneously.

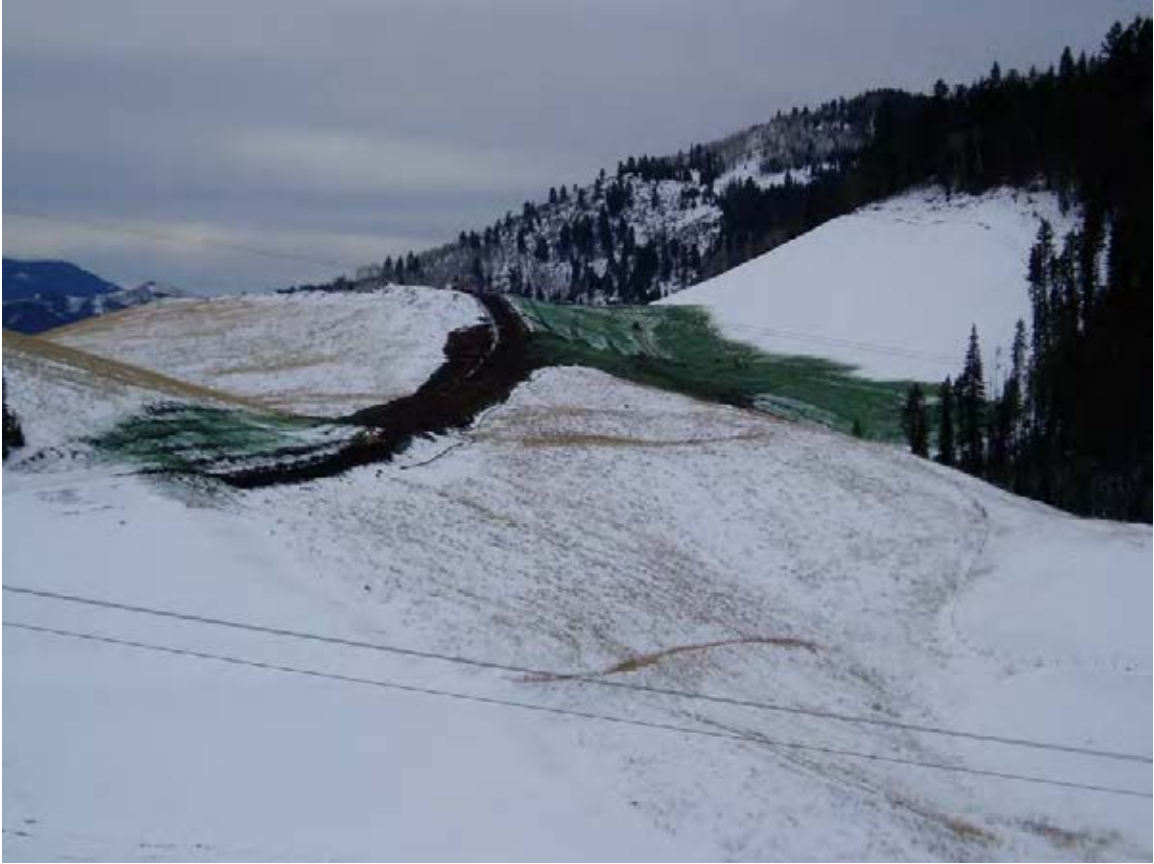
Photograph 4b: Looking southwest at north end of Dinwoody borrow as reclamation nears completion. Installation of erosion control straw wattles and hydroseeding in progress.

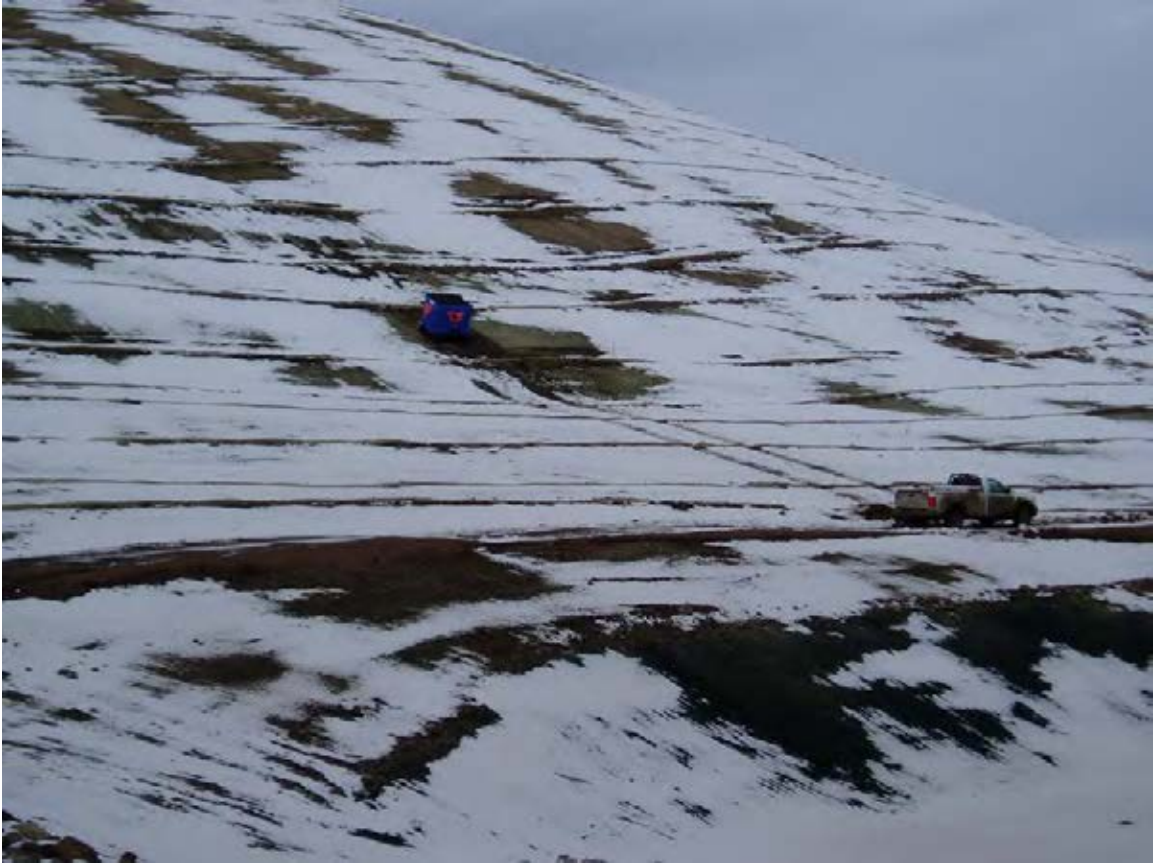
Photograph 5a: Looking northeast at the south facing slope of the East Side ODA cover ES-R2. Tent in center of photograph is covering borehole infiltrometer test being conducted for CU7.

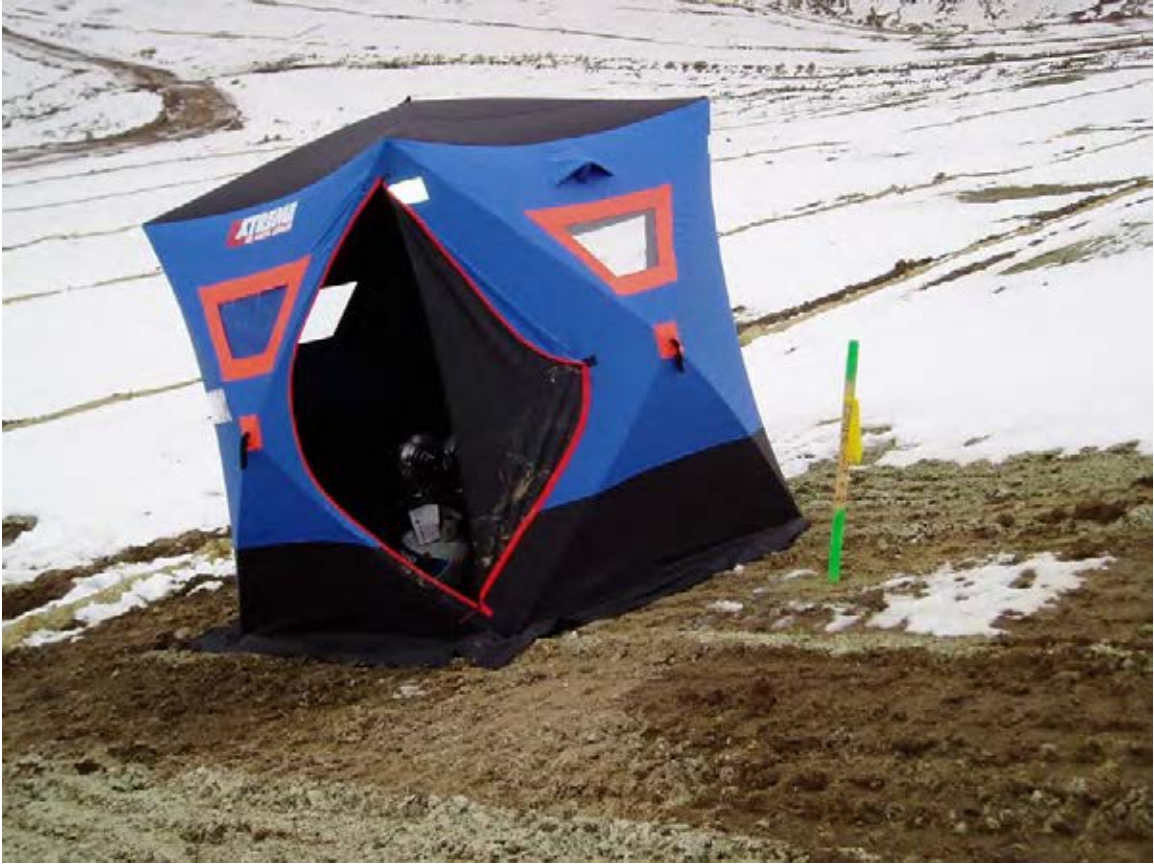
Photograph 5b: Looking southwest at tent covering infiltrometer test for CU7.

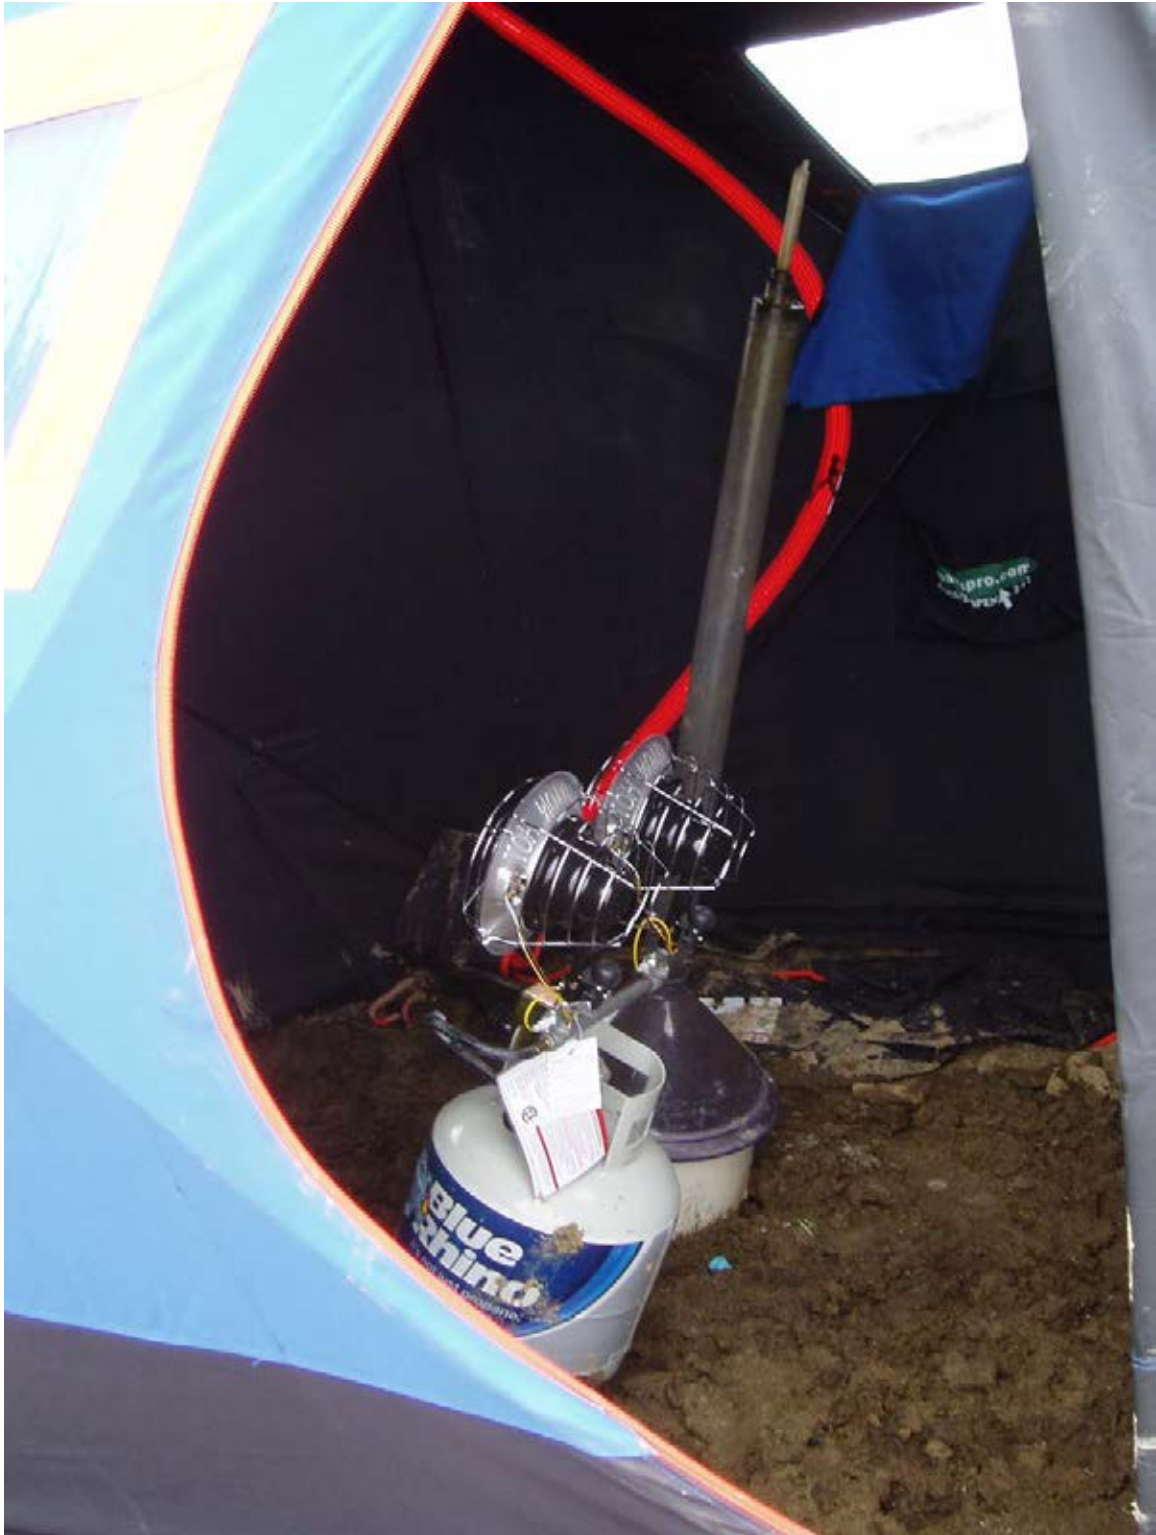
Photograph 5c: Looking into tent covering infiltrrometer test for CU7. Tent and propane heater were used to keep test apparatus from freezing.

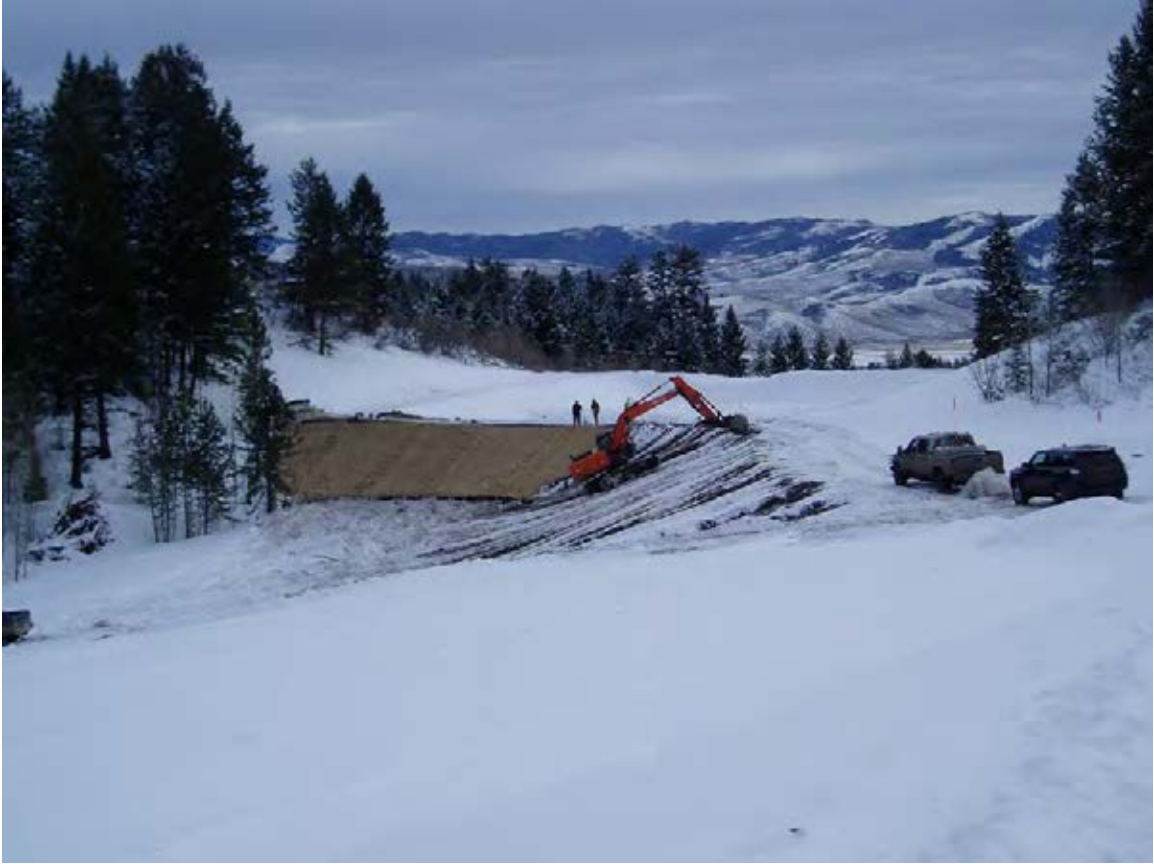
Photograph 1a: Looking southeast towards Saddle Infiltration Basin at the north embankment as workers install straw erosion control matting.

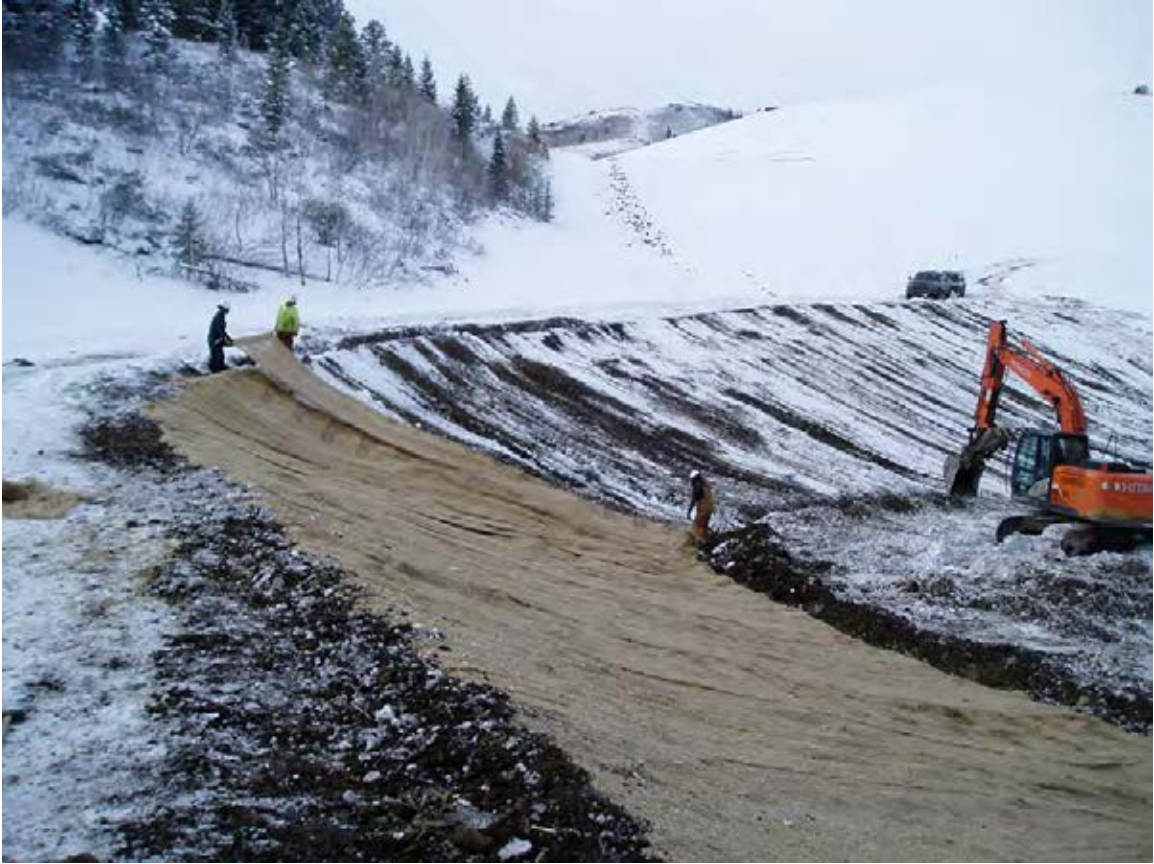
Photograph 1b: Looking northwest along the north embankment of the Saddle Infiltration Basin as workers install straw erosion control matting.

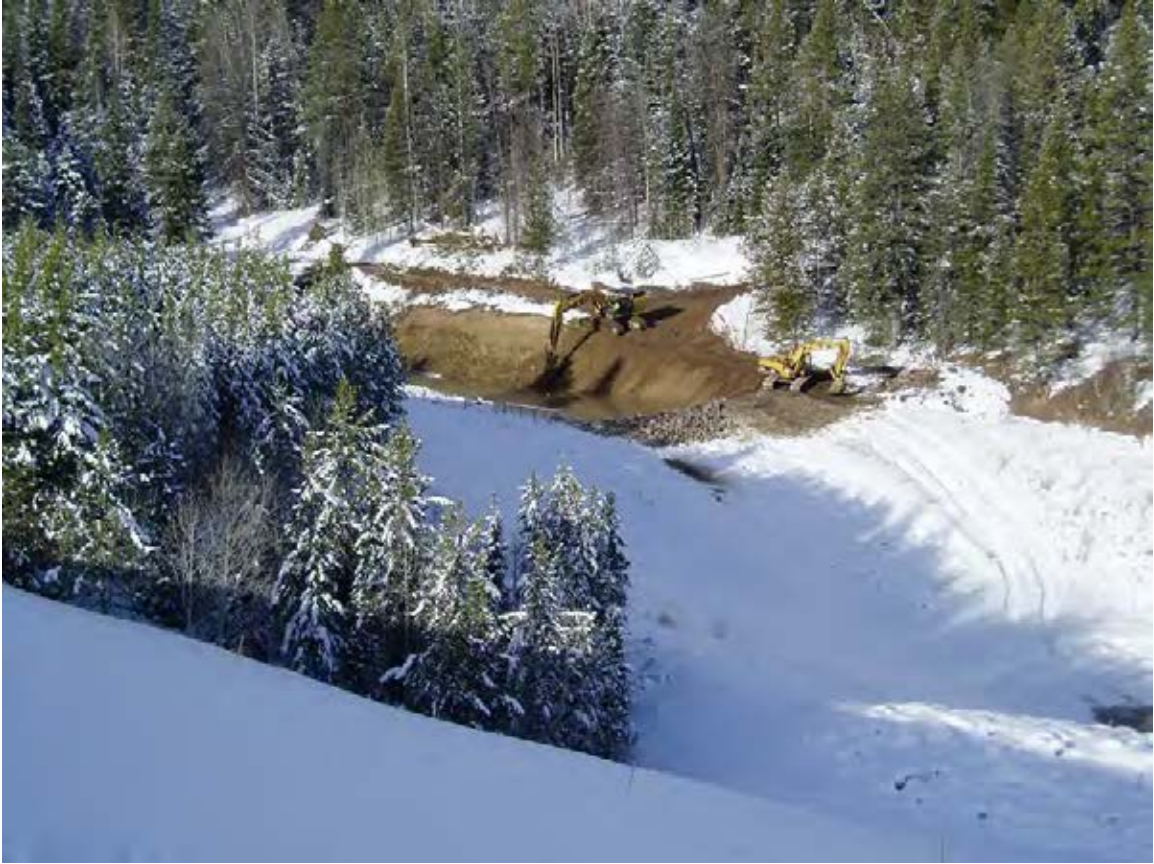
Photograph 2a: Looking northwest towards West Sedimentation Basin as excavators finish excavation along north embankment slope.

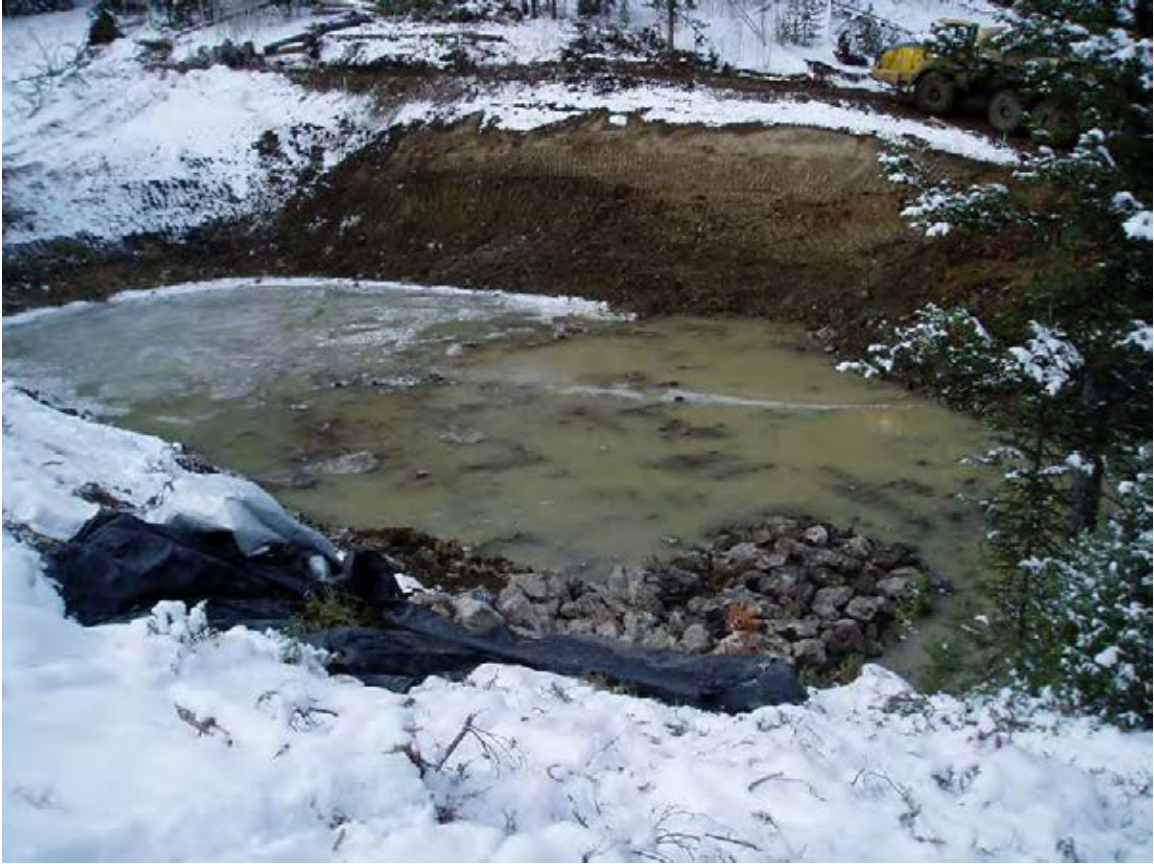
Photograph 2b: Looking north at the recently completed excavation for the West Sedimentation Basin and West Runoff Control Ditch outfall chute into basin.

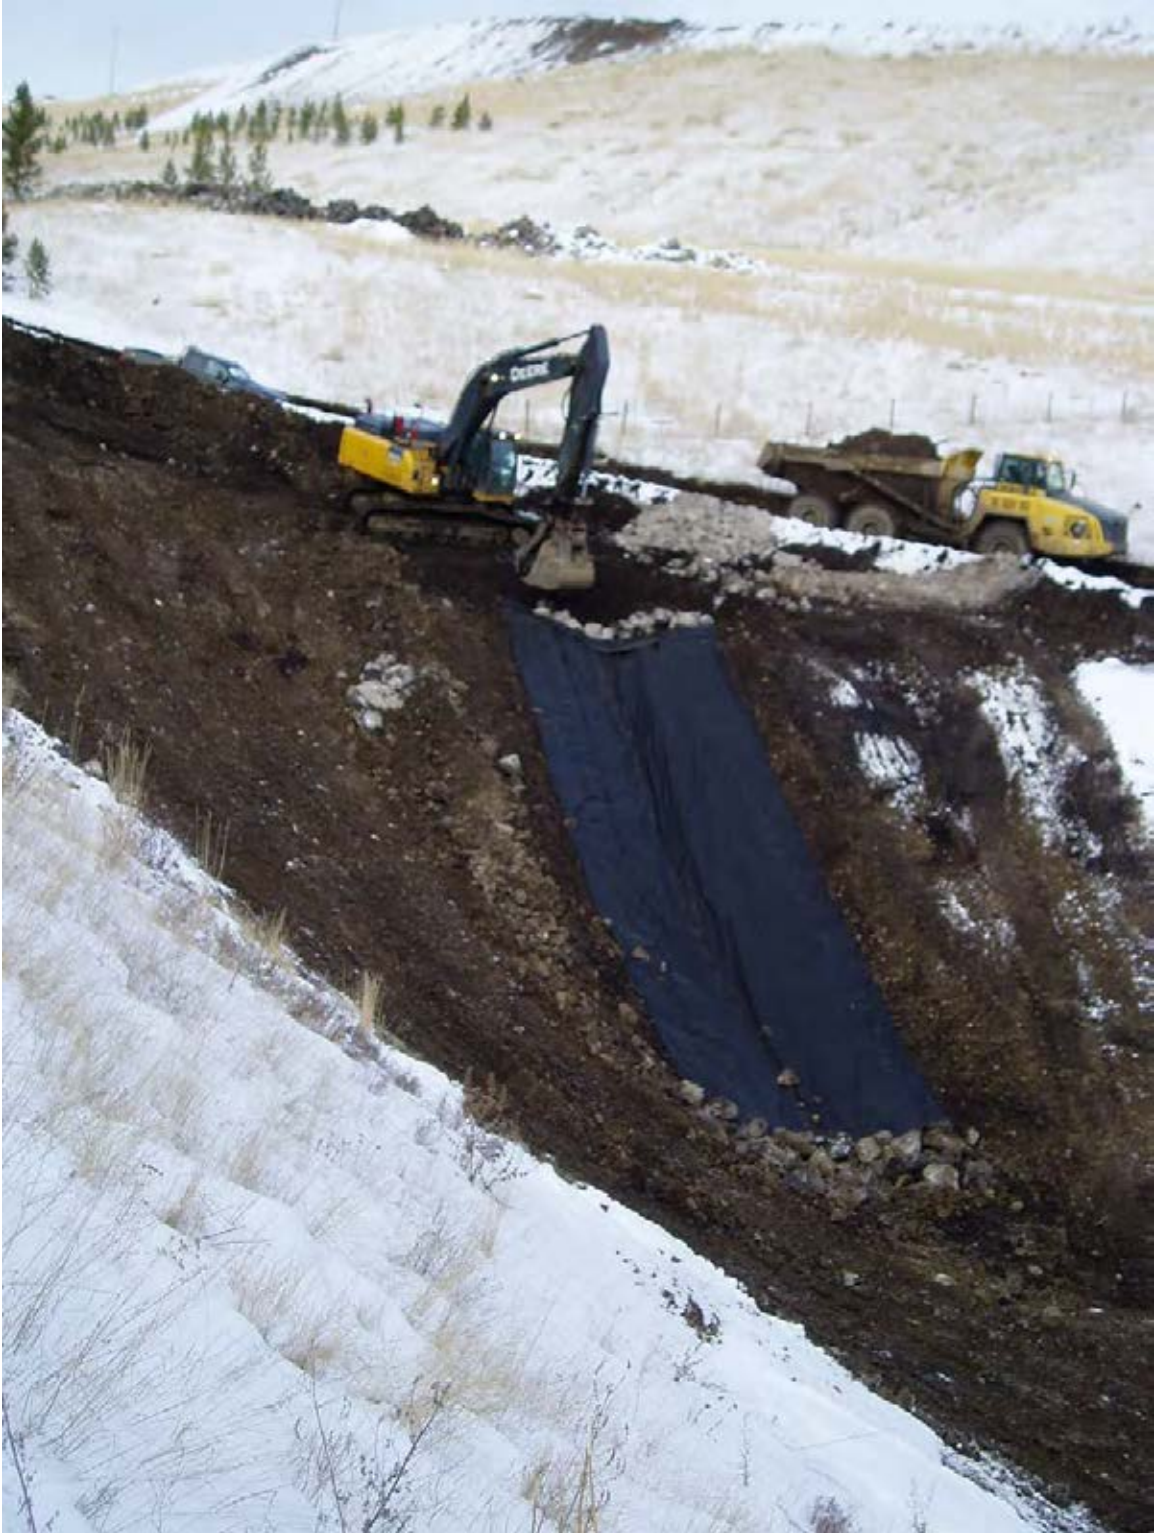
Photograph 3a: Looking northeast as excavator places rip rap on top of geofabric liner for Northwest Sedimentation Basin inlet chute to Cell 1.

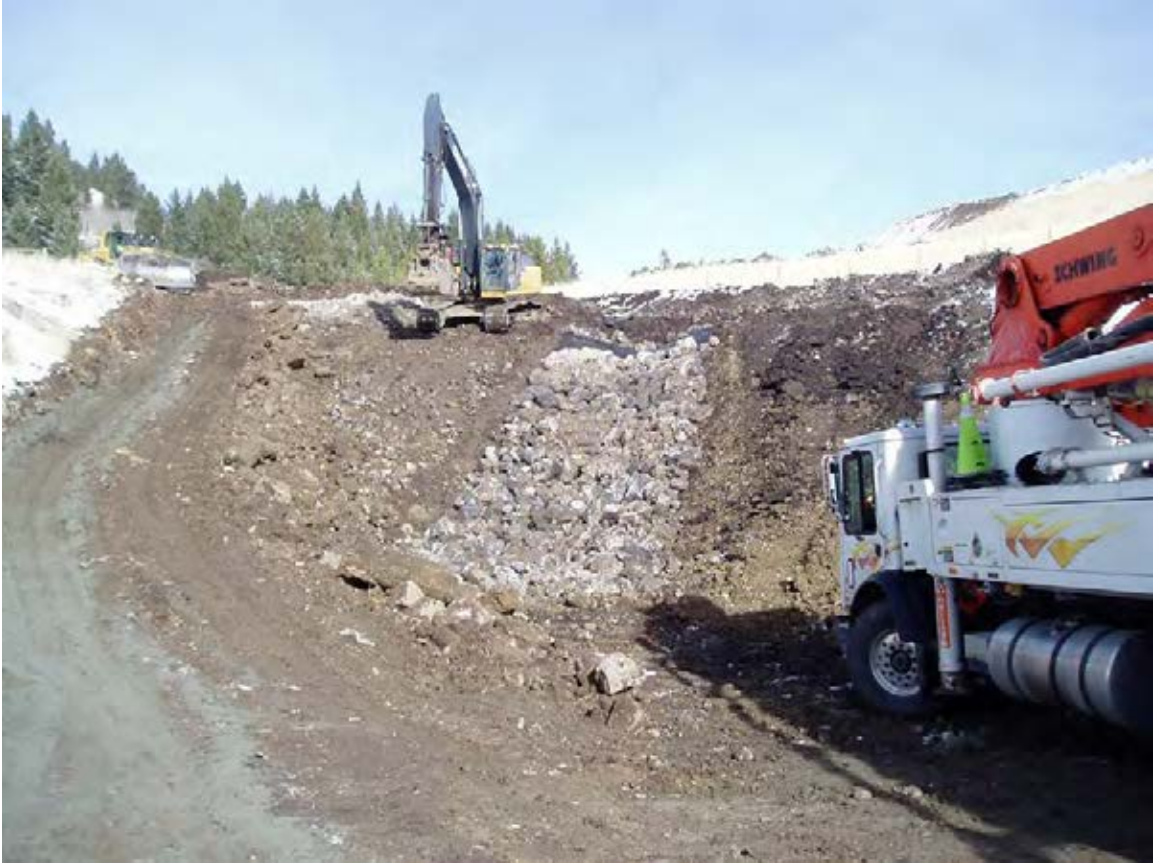
Photograph 3b: Looking north towards the inlet chute of the Northwest Sedimentation Basin as excavator places rocks for rip rap lining on top of geofabric.

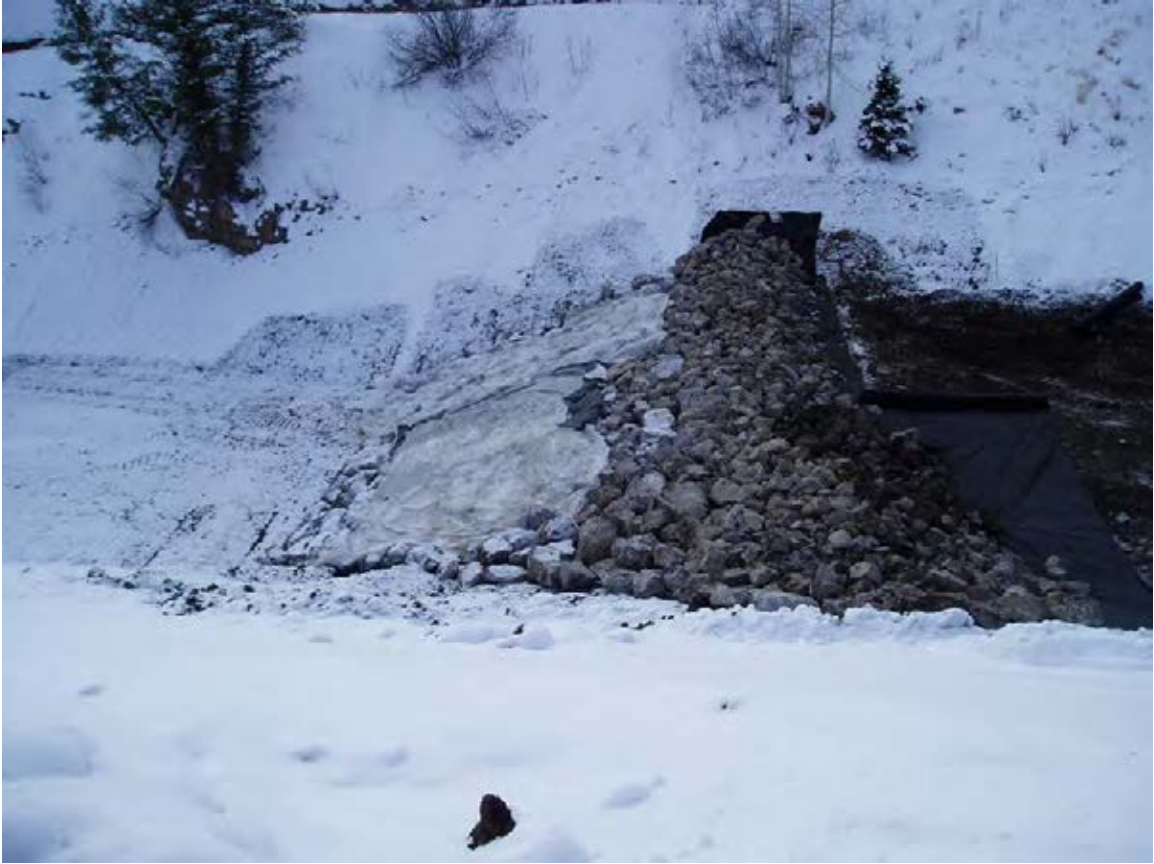
Photograph 4: Looking west at rip rap placed for the flow through rock berm separating Cell 1 on right, from Cell 2 on left of Northwest Sedimentation Basin. Plastic on the lower portion of rip rap face is to prevent snow from filling void between rocks until it is grouted.

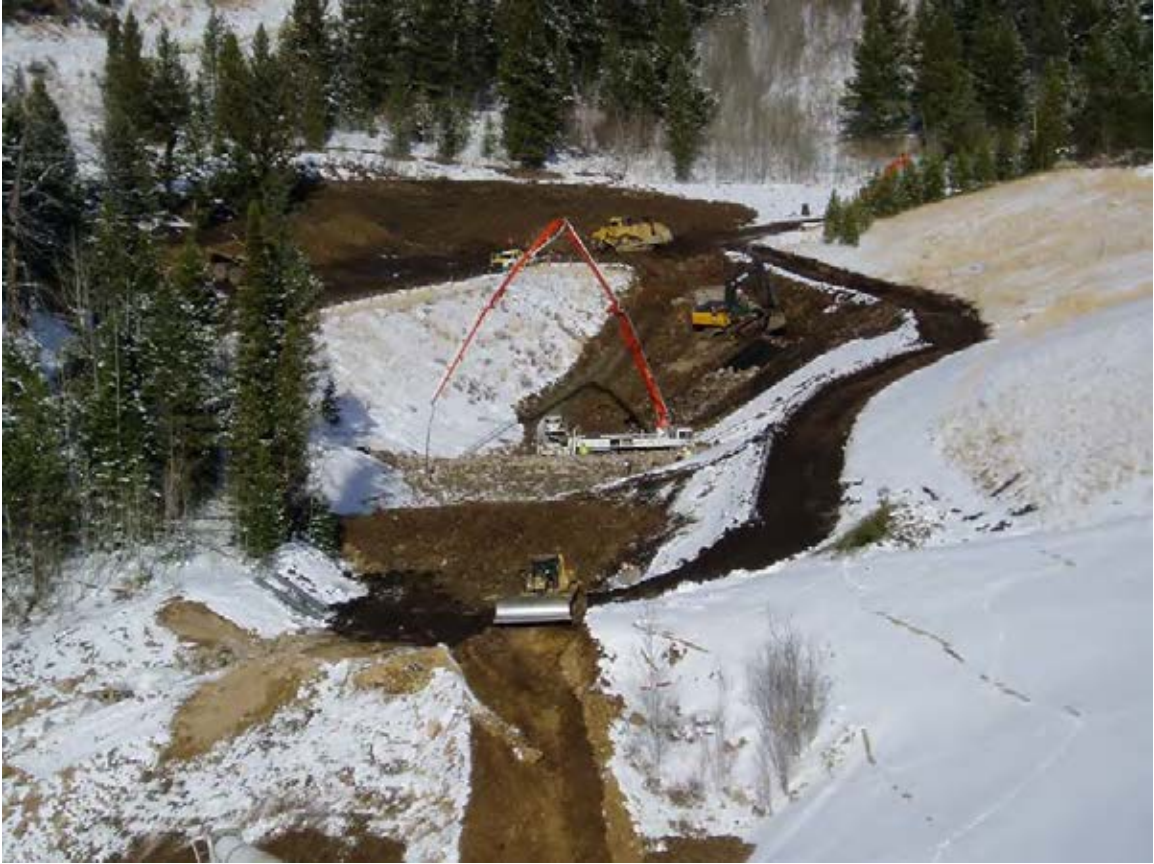
Photograph 5a: Looking northwest at the Northwest Sedimentation Basin as grout is being pumped into place for the downstream face of the flow through rock berm outfall. Excavator in background is placing riprap into channel of inlet chute.

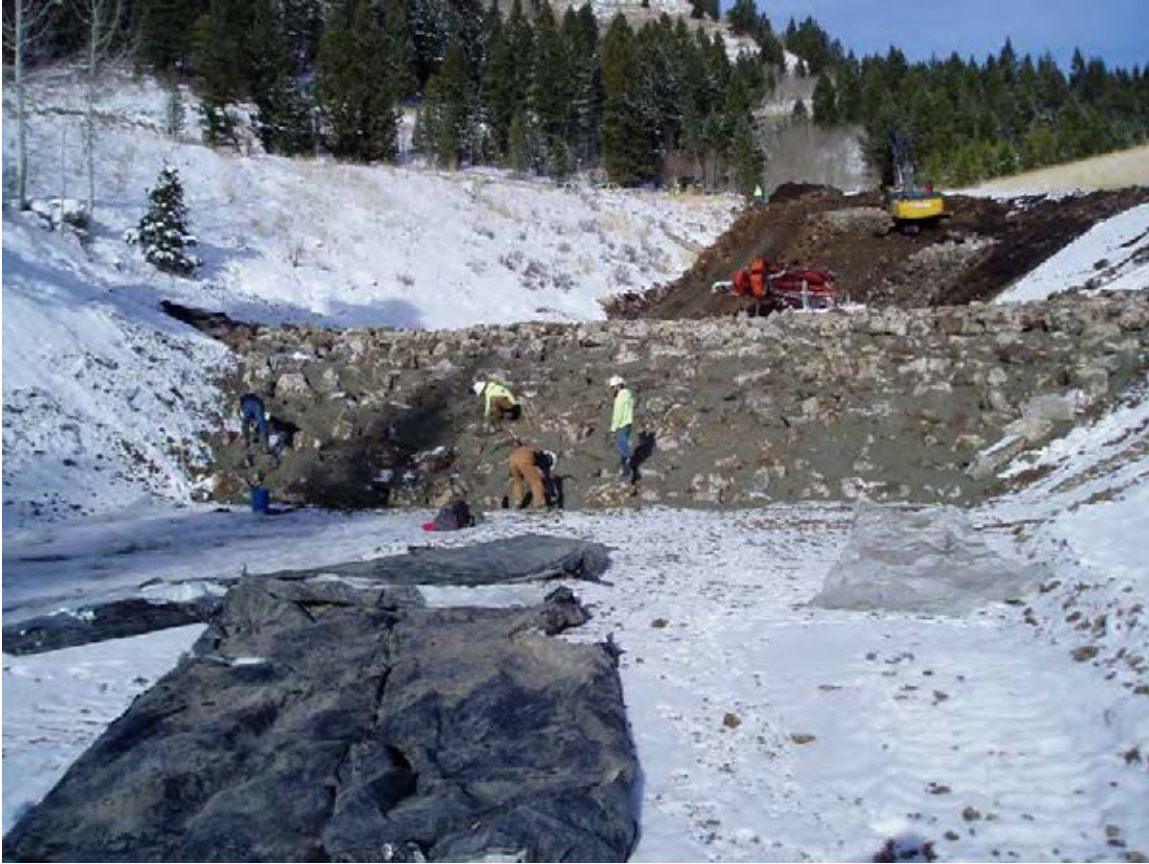
Photograph 5b: Looking northwest at the downstream face of the flow through rock berm between Cell 1 and Cell 2 of the Northwest Sedimentation Basin. Grout, recently placed on the downstream face of the rock berm is being worked into place to insure proper placement and coverage. Grout was only place up to the crest of the rip rap to allow flow from the base of Cell 1 through the rock berm filter onto the grouted rip rap lined face of Cell 2.
